Lower Owens River Project

2008 *Final Annual Monitoring Draft Report*

Prepared by: Los Angeles Department of Water and Power,
Inyo County Water Department,
and
Ecosystem Sciences, Inc.

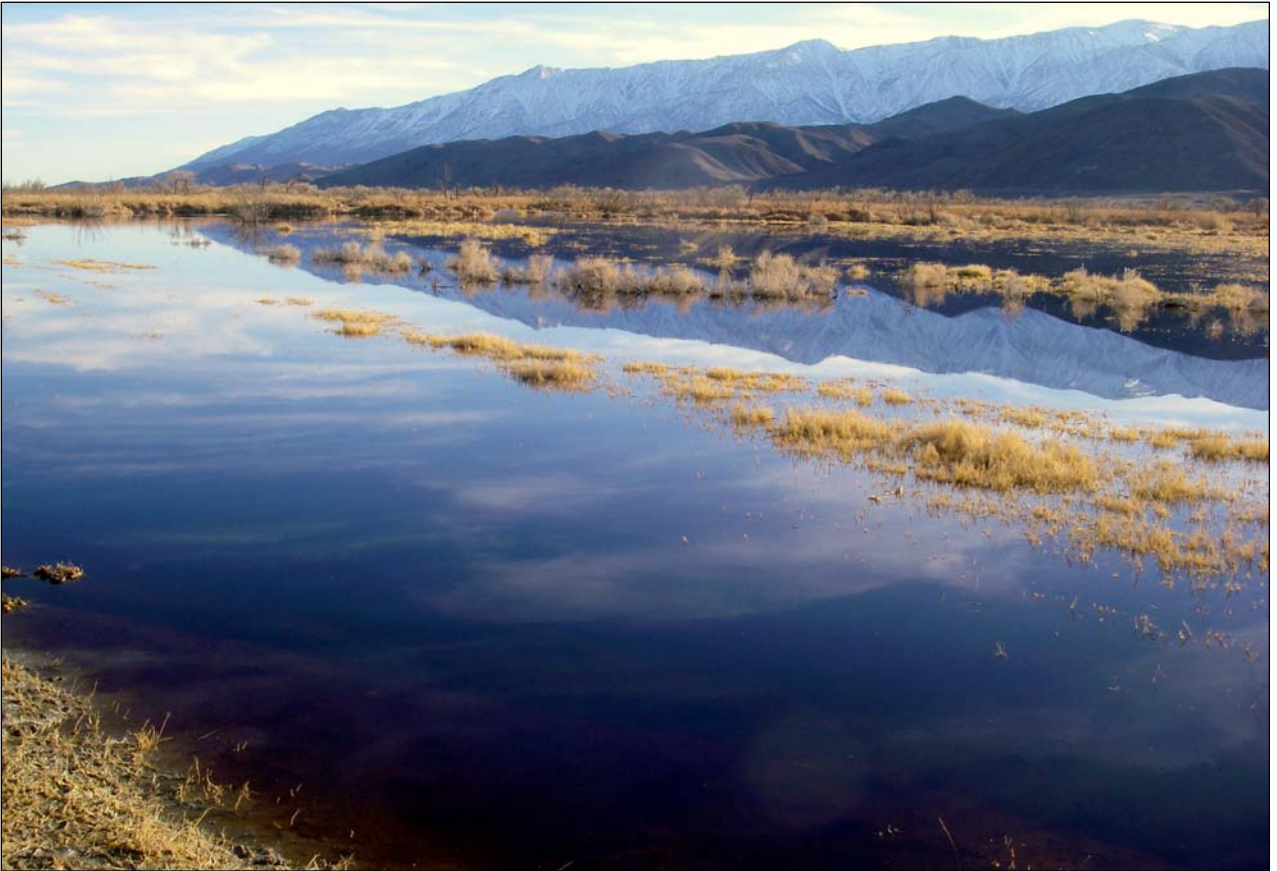
Seasonal Habitat Flow Figure 1. Seasonal Habitat Flooding in the Lower Owens River.

In this reach of the river near the Alabama Hill's and upstream of Lone Pine landforms are inundated from terrace to terrace across the floodplain at 200 cfs.

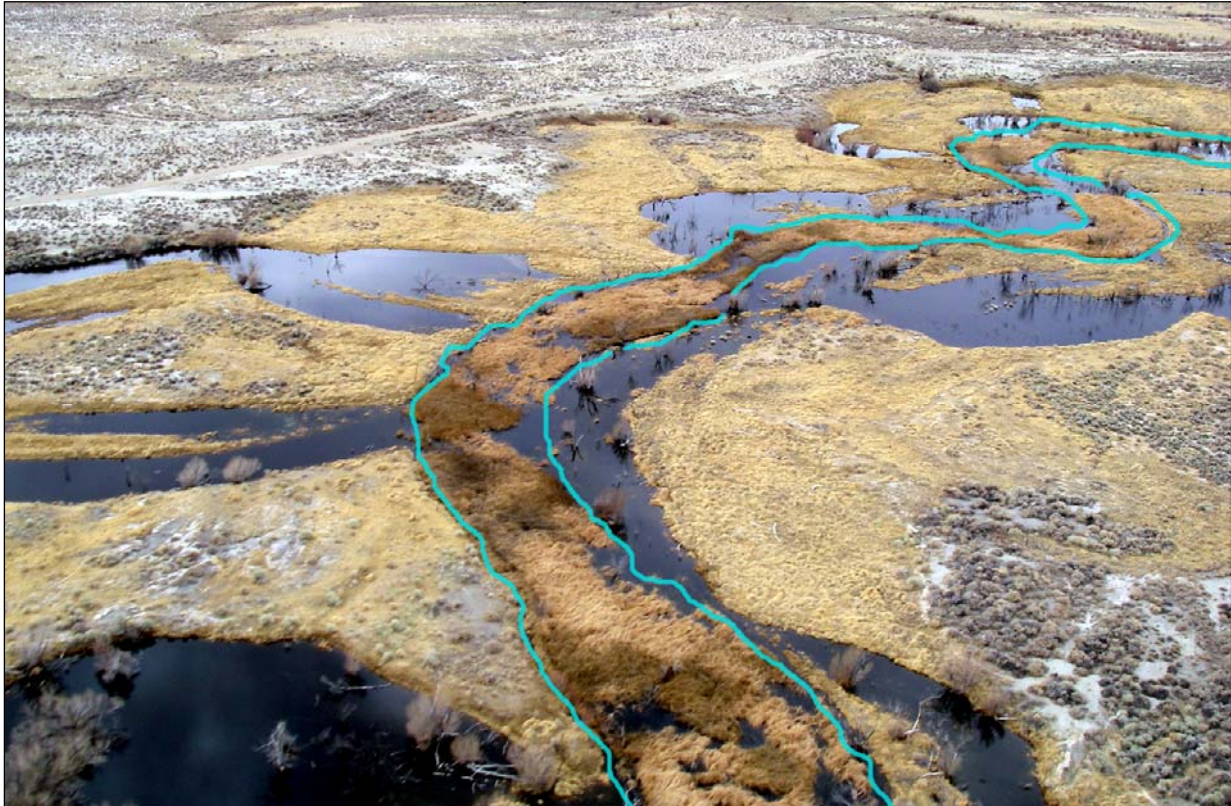
Seasonal Habitat Flow Figure 2. Oblique Aerial Photo of Seasonal Habitat Flooding in the LORP.

Pictured is a flooded reach of the river at approximately 175 cfs. The green-blue line in the photo represents the confined river channel and wetted edge under baseflow conditions. This reach of the river was significantly inundated with flooding during the high flows.

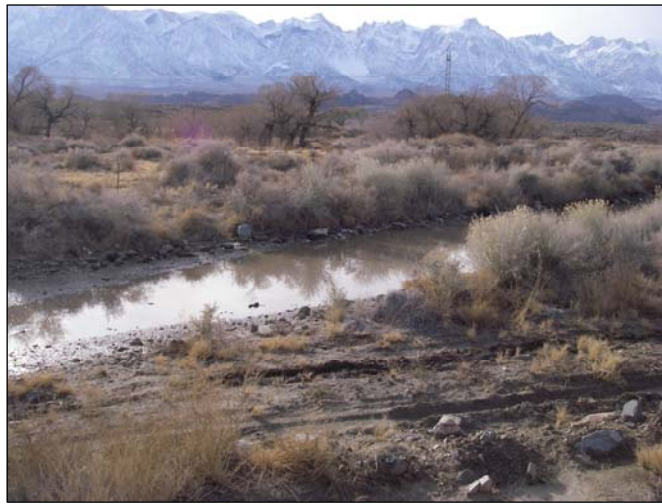
Seasonal Habitat Flow Figure 4. Ponding on Primary Access Road to Keeler Weir Near Lone Pine, CA.

Note the alternative route in the foreground created by vehicles trying to access the river.

In January, winter precipitation caused flooding on terrace and floodplain surfaces in and adjacent to the Lower Owens River. Several river access roads were closed in January because of ponding (Seasonal Habitat Flow Figure 4).

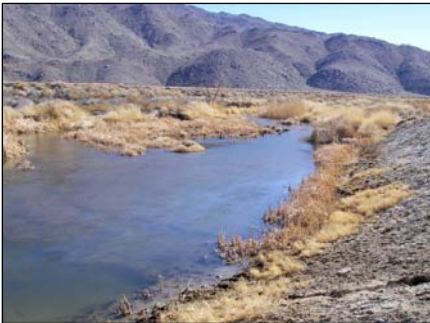
Below Blackrock Return Ditch at 50 cfs.

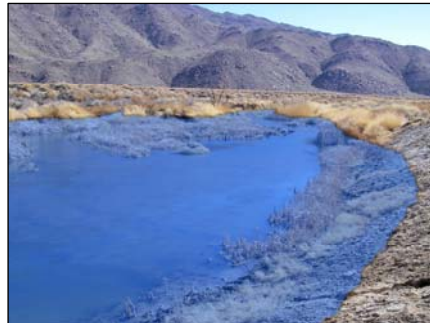
Below Blackrock Return Ditch at 50 cfs with 200 cfs flow overlay (blue layer). Note that emergent vegetation and Instream islands are fully inundated by flow.

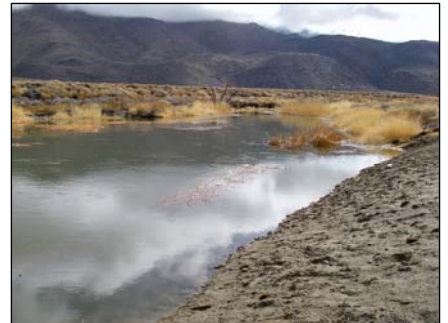
Below Blackrock Return Ditch at 200 cfs.

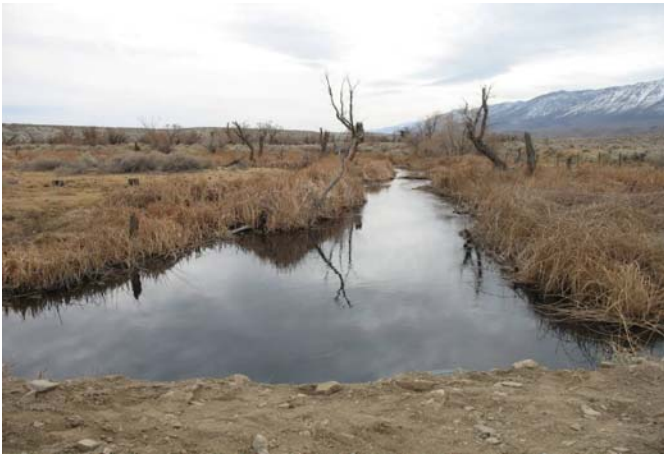
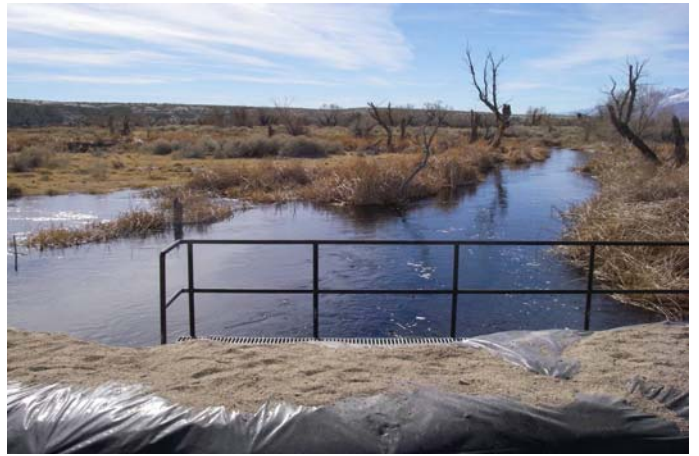
Facing Downstream – 50 cfs 2/19/2008

Facing Downstream – 202 cfs 2/27/2008

Seasonal Habitat Flow Figure 15. Qualitative Comparison of Lone Pine Narrow Gauge Road Photo Point.

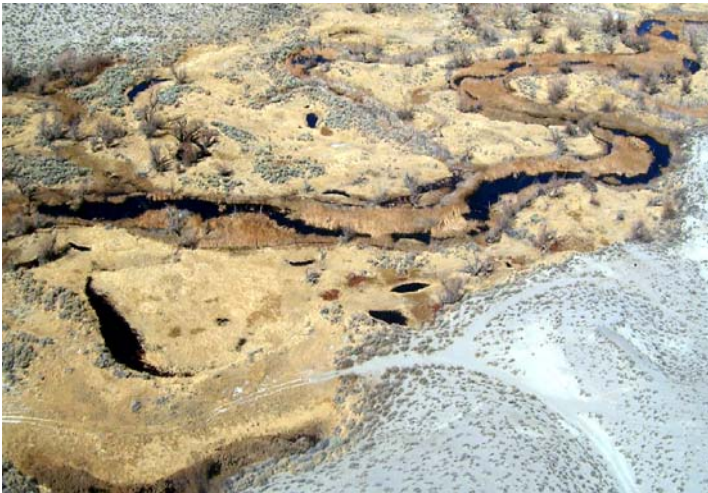
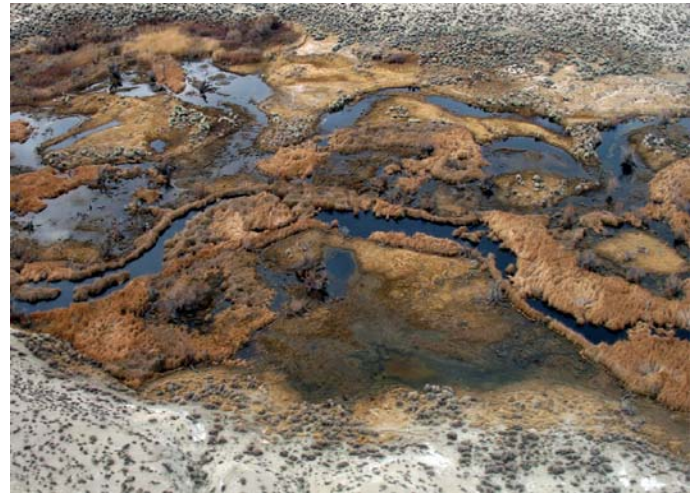
River Near Lone Pine – 47 cfs 2/17/2007

River Near Lone Pine – 200 cfs 3/1/2008

Seasonal Habitat Flow Figure 16. Qualitative Comparison of River Floodplain Inundation/Flooded Extent Near Lone Pine. The left photo shows the river at base flow, right photo shows the river and inundated floodplain at high flow.

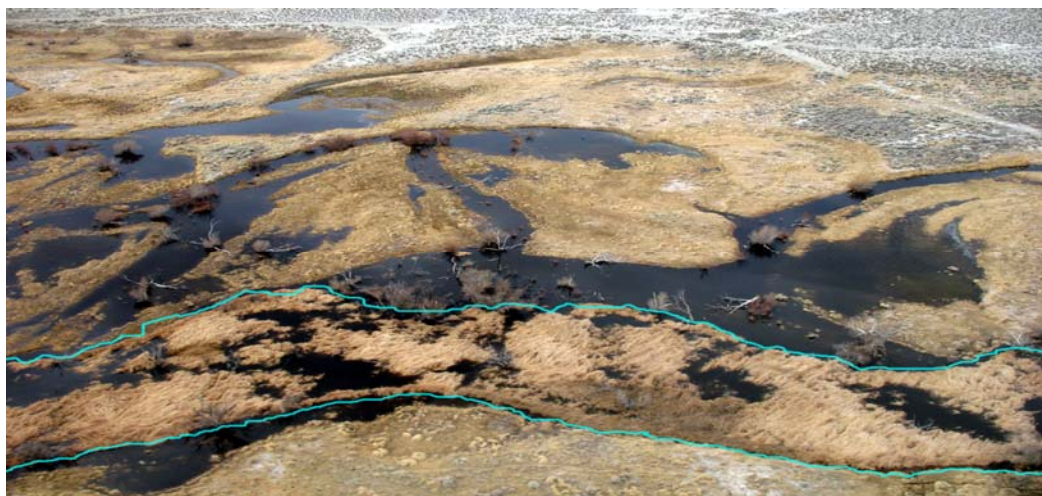
River floodplain inundated at high flow – 200 cfs 3/1/2008

Seasonal Habitat Flow Figure 17. Picture is a Flooded Reach of the River at Approximately 200 cfs.

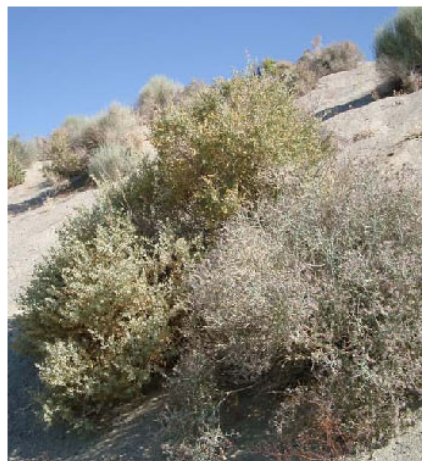
Plot	1	2	3	4	5	Total
Cover %	0.0	0.0	2.6	8.2	6.0	3.3
Mean plot pos.:						4.2
Ave. patch length (m):						24
WWI score:						(UPL)3.8
Dominant sp. Origin:						native
Community complex:						Saline scrub
Species abundance:						
# of dominant species in transects:						15
Total species in subplots:						11

n=64 Groundcover n=13

Most Common Dominant Species	Dom. score	% Freq	IV	Cover type	%
<i>Atriplex confertifolia</i>	2.8	95	60	bare ground	91
<i>Sarcobatus vermiculatus</i>	1.2	45	6	litter	5
<i>Psoralea polydenius</i>	1.0	41	37	vegetation	4
<i>Chrysothamnus nauseosus</i>	0.6	25	2	dead shrub	<1
<i>Atriplex canescens</i>	0.4	17	13	downed wood	<1
<i>Salsola tragus</i>	0.2	8	0	cow manure	<1
<i>Suaeda moquinii</i>	0.2	9	0

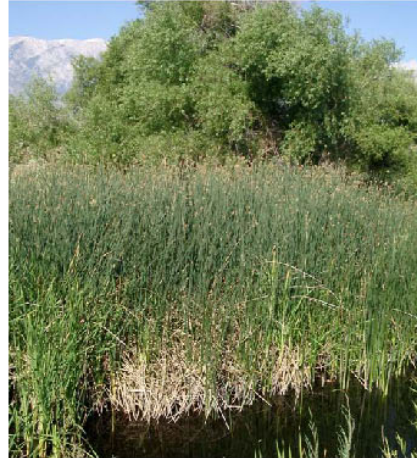
Vegetation Type: Bull Rush- Cattail-Willow Wetland

Community Characteristics:						
Plot	1	2	3	4	5	Total
Cover %	0.0	0.0	2.0	12.3	2.6	4.1
Mean plot pos.:						4.3
Ave. patch length (m):						22
WWI score:						(OBL) 1.0
Dominant sp. Origin:						native
Community complex:						Emergent wetland
Species abundance:						
# of dominant species in transects:						10
Total species in subplots						7

n=51	Groundcover	n=10
Most Common Dominant Species	Dom. score	% Freq	IV	Cover type	%
<i>Scirpus acutus</i>	2.7	100	83	water	38
<i>Typha latifolia</i>	1.4	55	15	litter	31
<i>Salix gooddingii</i>	0.7	24	3	vegetation	25
<i>Salix laevigata</i>	0.1	4	1	downed wood	5
<i>Atriplex lentiformis</i>	0.1	2	0	bare ground	1
<i>Polygonum hydropiperoides</i>	0.1	4	2	cow manure	<1
<i>Lemna sp.</i>	0.1	2	1

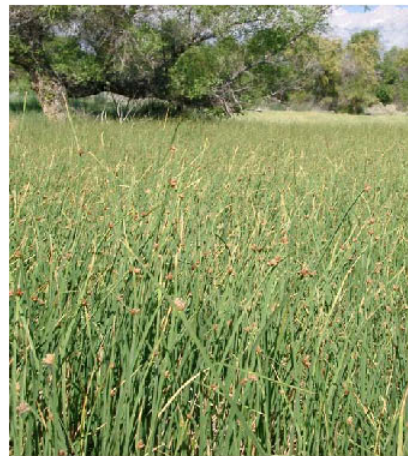
Plot	1	2	3	4	5	Total
Cover %	0.0	0.0	1.1	2.9	1.3	1.2
Mean plot pos.:						4.1
Ave. patch length (m):						8
WWI score:						(OBL-) 1.4
Dominant sp. Origin:						native
Community complex:						Willow wet meadow
Species abundance:						
# of dominant species in transects:						21
Total species in subplots						19

n=54		Groundcover		n=8	
Most Common Dominant Species	Dom. score	%Freq	IV	Cover type			%
<i>Scirpus americanus</i>	2.9	100	63	vegetation			45
<i>Distichlis spicata</i>	1.2	48	3	litter			45
<i>Anemopsis californica</i>	0.9	33	6	bare ground			10
<i>Juncus balticus</i>	0.4	15	1	cow manure			1
<i>Tamarix ramosissima</i>	0.2	7	0				
<i>Polypogon monspeliensis</i>	0.1	6	2				
<i>Xanthium strumarium</i>	0.1	6	1

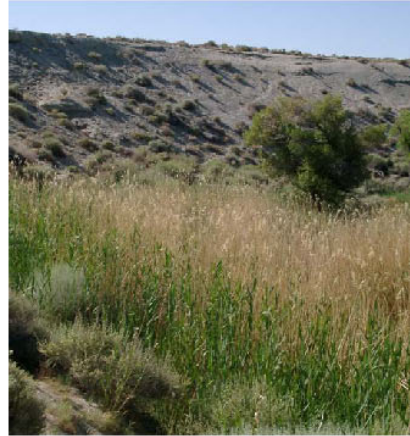
Plot	1	2	3	4	5	Total
Cover %	0.0	0.0	0.1	2.4	1.9	0.9
Mean plot pos.:						4.5
Ave. patch length (m):						16
WWI score:						(FACW+) 1.7
Dominant sp. Origin:						native
Community complex:						Common Reed
Species abundance:						
# of dominant species in transects:						15
Total species in subplots						12

n=27			Groundcover	n=6	
Most Common Dominant Species	Dom. score	% Freq	IV	Cover type	%	
<i>Phragmites australis</i>	3.0	100	87	litter	65	
<i>Anemopsis californica</i>	1.4	48	13	vegetation	32	
<i>Salix exigua</i>	1.0	33	8	water	2	
<i>Apocynum cannabinum</i>	0.3	15	15	bare ground	1	
<i>Chrysothamnus nauseosus</i>	0.3	15	1	cow manure	<1	
<i>Typha latifolia</i>	0.3	11	1			
<i>Helianthus annuus</i>	0.2	11	1

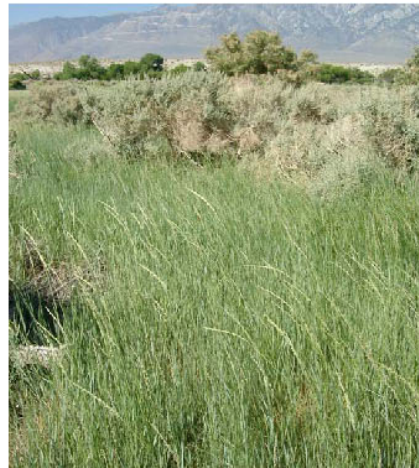
Plot	1	2	3	4	5	Total
Cover %	0.0	0.0	0.6	2.8	6.4	2.0
Mean plot pos.:						1.5
Ave. patch length (m):						11
WWI score:						(FAW-) 2.2
Dominant sp. Origin:						native
Community complex:						Willow wet meadow
Species abundance:						
# of dominant species in transects:						21
Total species in subplots:						23

n=89 Groundcover

Most Common Dominant Species	Dom. score	%Freq	IV	Cover type	%
<i>Leymus triticoides</i>	2.8	99	46	vegetation	60
<i>Distichlis spicata</i>	2.3	78	8	litter	28
<i>Glycyrrhiza lepidota</i>	0.6	26	5	bare ground	6
<i>Atriplex lentiformis</i>	0.5	18	0	downed wood	4
<i>Juncus balticus</i>	0.3	12	1	dead shrub	1
<i>Scirpus americanus</i>	0.2	9	0	cow manure	1
<i>Anemopsis californica</i>	0.2	9	0

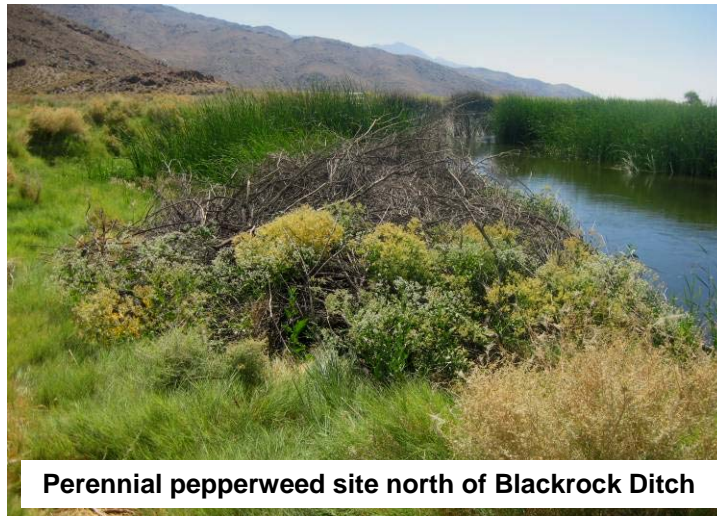
Perennial pepperweed (*Lepidium latifolium*) was documented in four different areas - two of which had not been previously documented. RAS Figure 3 shows the four general areas where perennial pepperweed was found are Drew Slough and three floodplain areas east of the river – 1) approximately 0.5 miles north of Blackrock Ditch, 2) 0.5 miles south of Manzanar Reward Road, and 3) 2 miles south of Manzanar Reward Road. The Drew Slough site and the sites 0.5 miles south of Manzanar Reward Road had not been previously documented or treated. The perennial pepperweed found in the Winterton Unit last year was not able to be relocated. Noxious Weed Documentation and Reporting Forms were filled out for each site and sent or hand-delivered to the Inyo/Mono County Agricultural Commissioners Office in Bishop. Further details of prior treatment of the sites or treatment since discovery can be found in the 2008 LORP Weed Report.

Perennial pepperweed site north of Blackrock Ditch

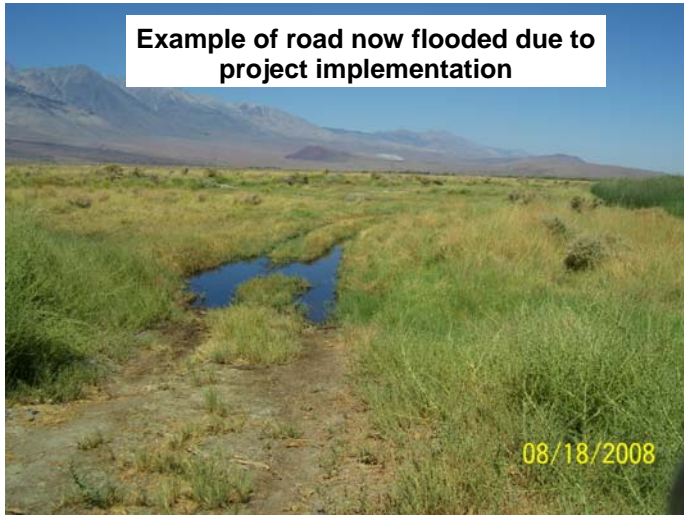
There were a few roads noted as being in the uplands on a terrace, but closely approaching the edge of the terrace (see photo). Although not in the floodplain, observers generally noted these areas due to their proximity to a steep, erodible cliff.

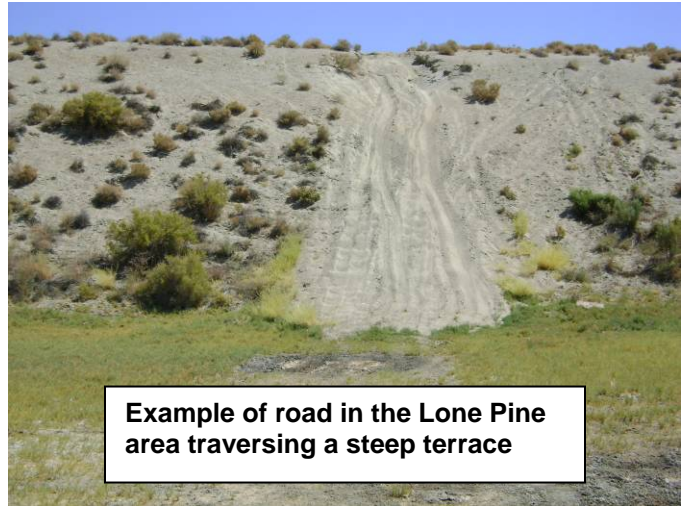
Example of road in the Lone Pine area traversing a steep terrace

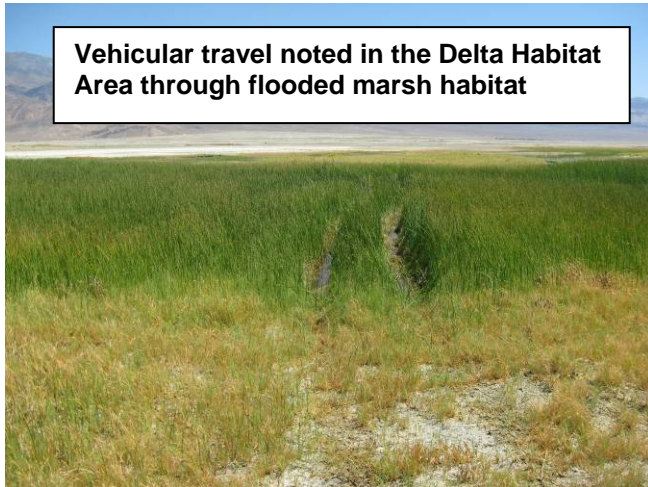
Roads were also noted in the BWMA and River Lakes and Ponds. In the BWMA, a few existing roads in the Thibaut and Winterton Units were also now flooded. At the south end of the Delta Habitat Area (DHA), ATV tracks were noted through wetland vegetation and across flooded playa (see photo below). The ATV tracks have been present at the south end of the DHA for some time, as workers on the lakebed have used ATVs to access monitoring sites. One observer noted vegetation impacts from travel through flooded marsh habitat, while a second observer noted that tracks through the area appeared more extensive and widespread than in previous years (i.e. not confined to previously-used travel routes).

Vehicular travel noted in the Delta Habitat Area through flooded marsh habitat

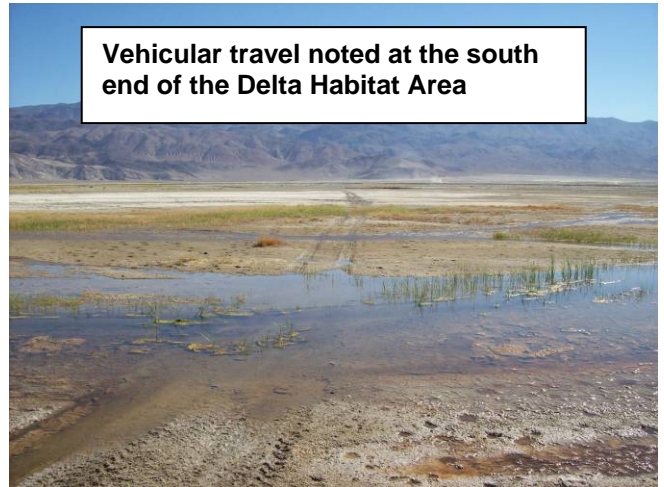
Vehicular travel noted at the south end of the Delta Habitat Area
