ATTACHMENT B
REGULATORY AUTHORITY

REGULATORY AUTHORITY

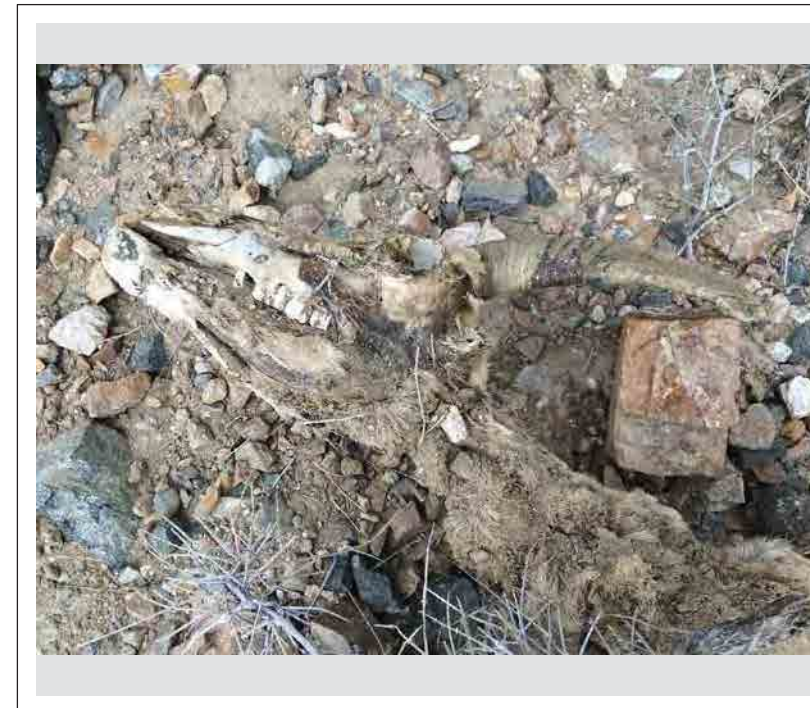
Desert bighorn sheep carcass observed east of Segment 7.
